## Letter Report

Intertek Report No. 101958618COQ-001  
Intertek Project No. G101958618

**Subject:** ETL Testing of the CTS Fabrication USA flange model - 2" BF002

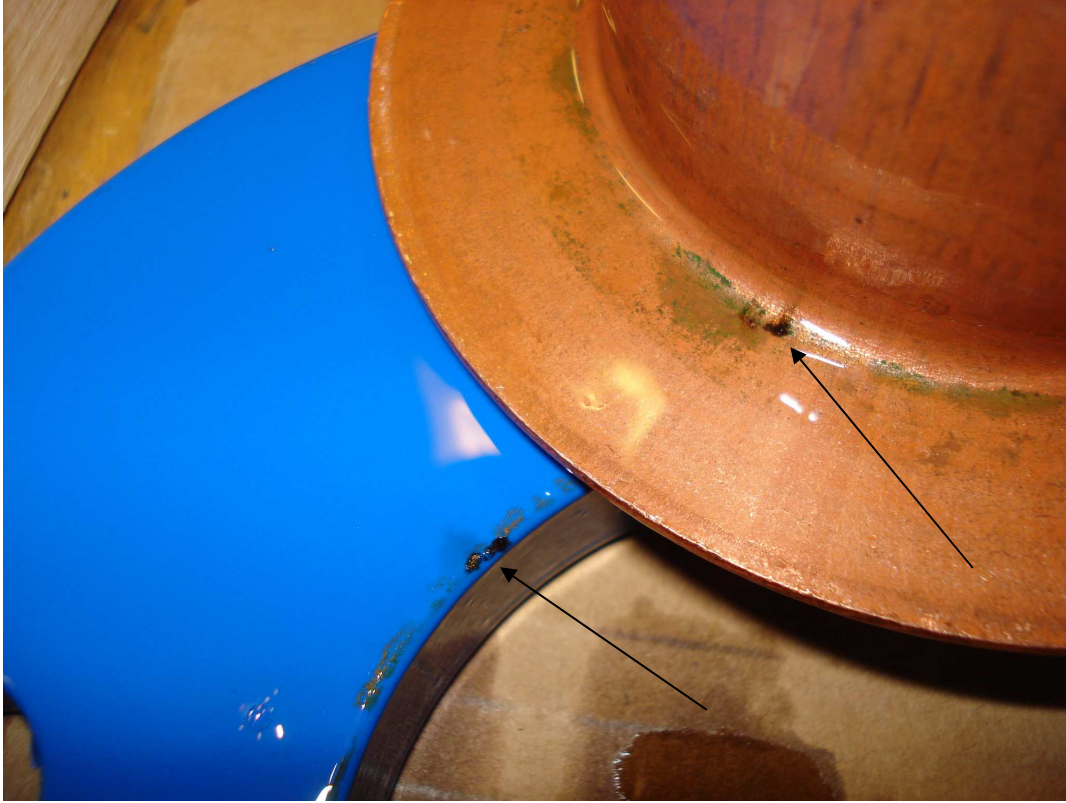
**Photo 1**

SPECIMEN	Dielectric Breakdown Voltage (kV)	Time to trip (Sec)	Location of failure
-001 (Non-insulated)	4	2.5	*Edge of flange (photo 1)
-002 (Insulated)	20	10	**Edge of flange (photo 2 & 3)

Without 'electrolysis insulator'

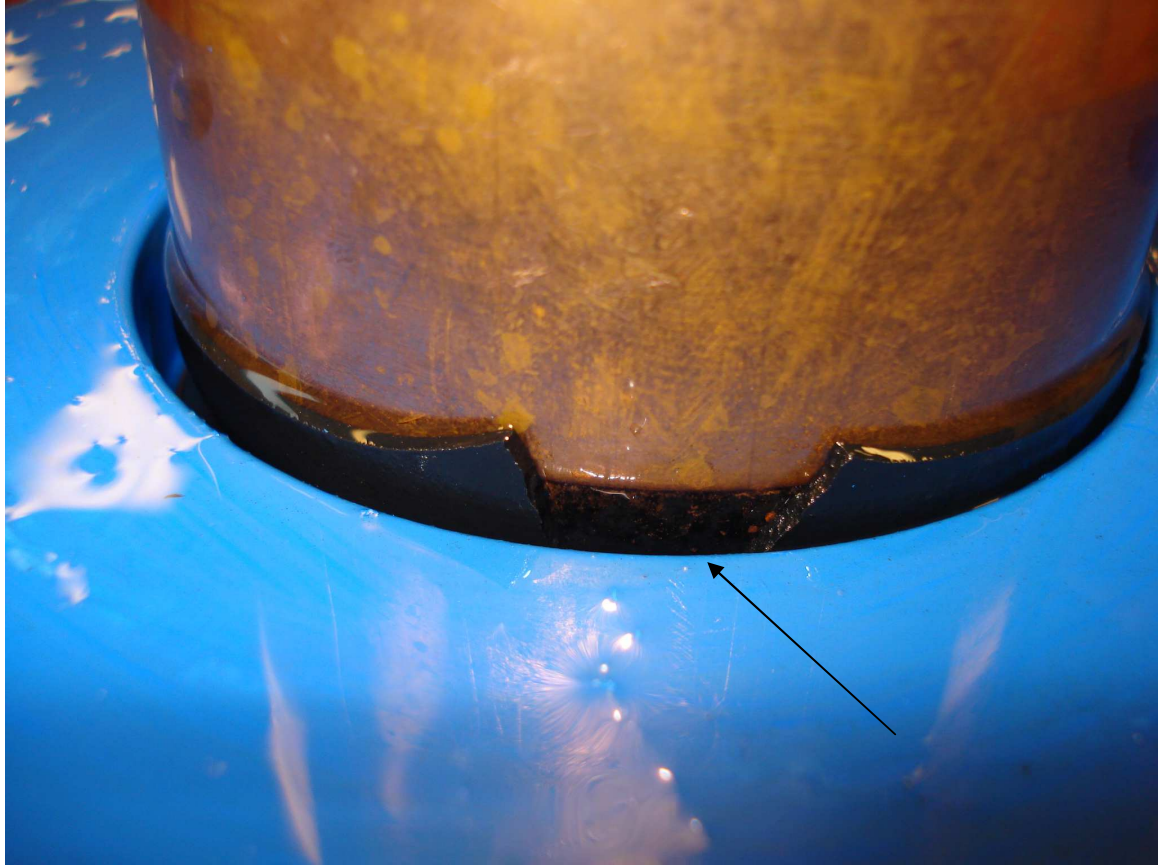
**Photo 2**

With 'electrolysis insulator'

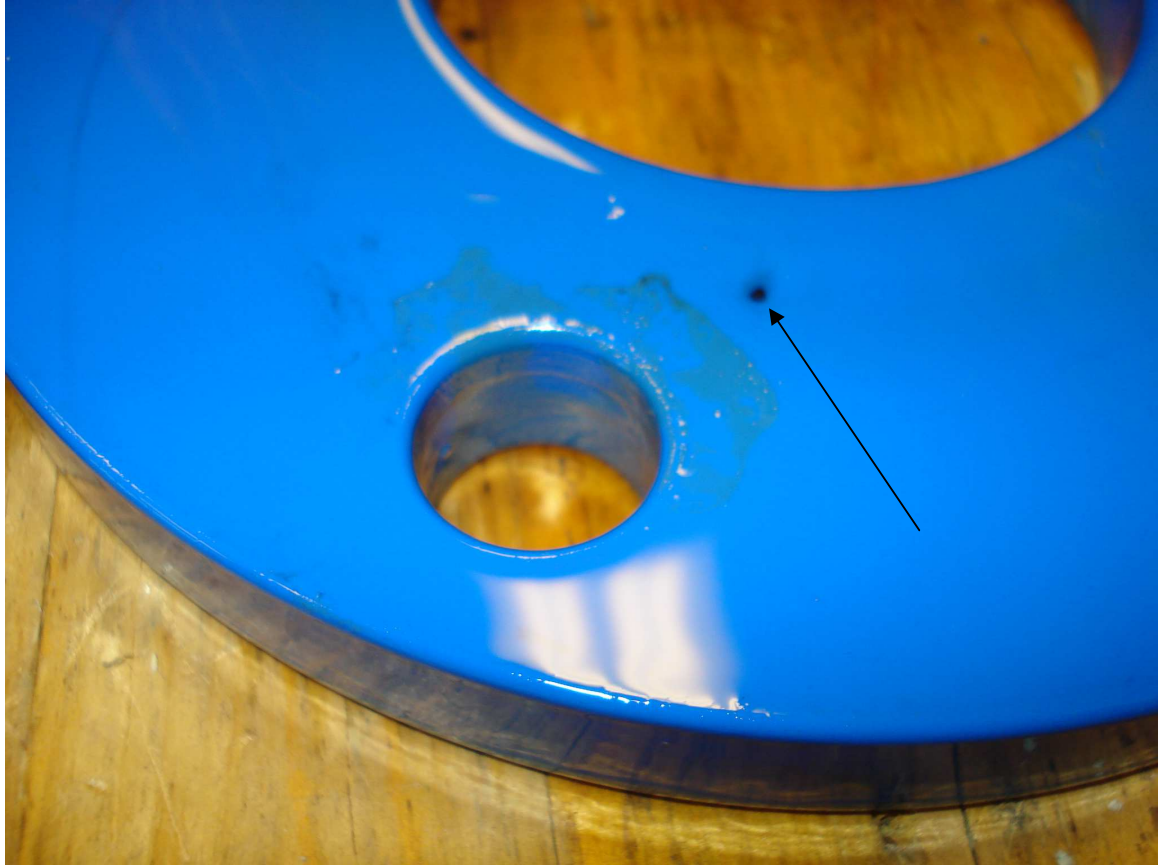
**Photo 3**

With 'electrolysis insulator'
